CORNELL-DUBILIER ELECTRONICS SITE

REVISED REMOVAL ACTION REPORT

DECEMBER 2009

Region II Removal Support Team 2, Weston Solutions, Inc. Edison, New Jersey 08837

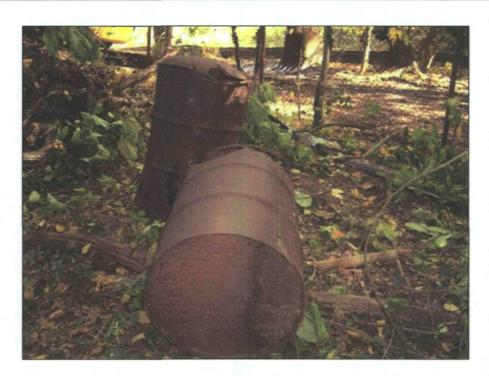
Picture 7: Two corroded drums retrieved from the western side of Spicer Avenue perimeter fence (October 15, 2008).

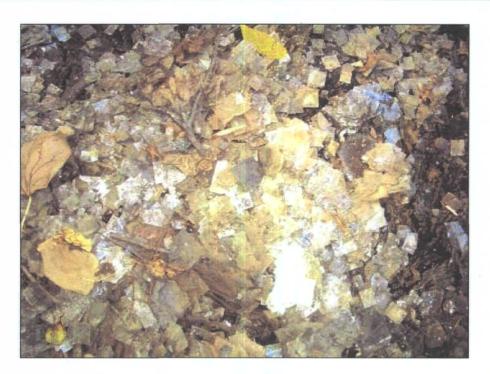
Picture 11: Detail of capacitor film uncovered near the southwest corner of the Site (October 15, 2008).

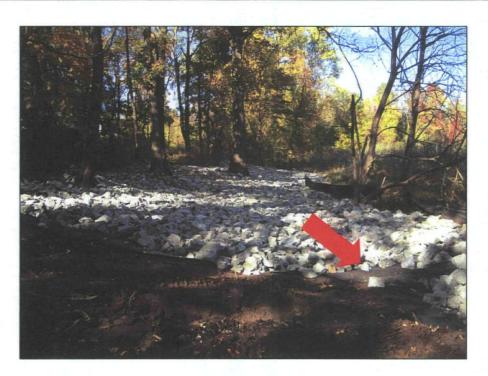
Picture 17: Rip-rap installed over geotextile material. Arrow indicates edge of geotextile underneath the rip-rap (October 17, 2008).

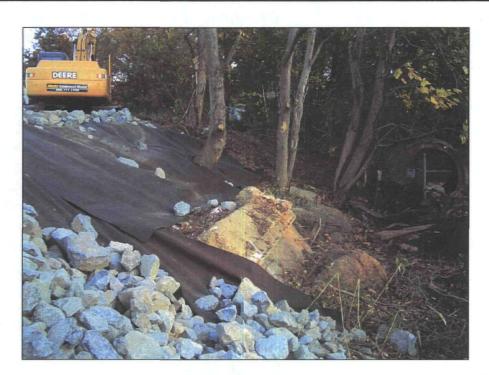
Picture 31: Stream bank adjacent to the twin culvert with geotextile installed (October 22, 2008).

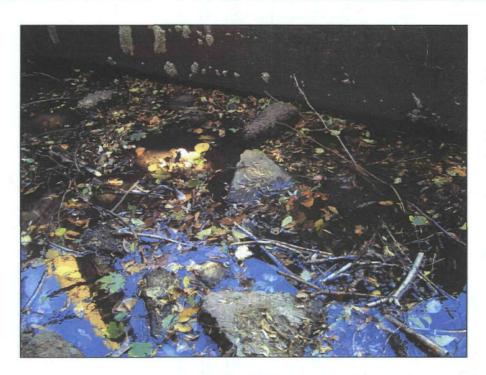
Picture 41: Debris at the upstream side of the downstream culvert prior to clearing (October 22, 2008).

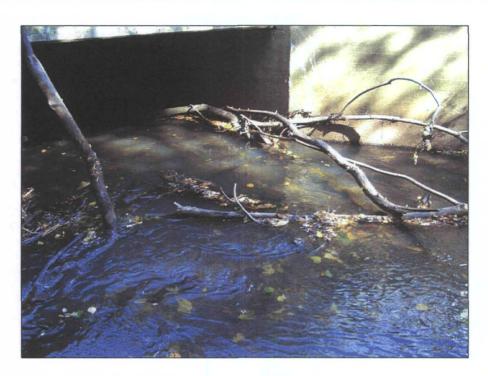
Picture 43: Debris at the upstream side of the downstream culvert prior to clearing (October 22, 2008).

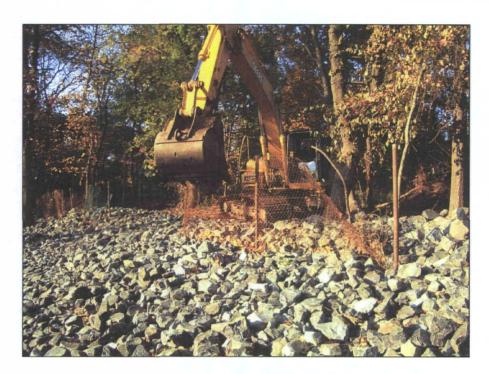
Picture 49: ERRS removing remnants of the damaged, existing chain link fence on the western bank adjacent to the wetlands area (October 27, 2008).

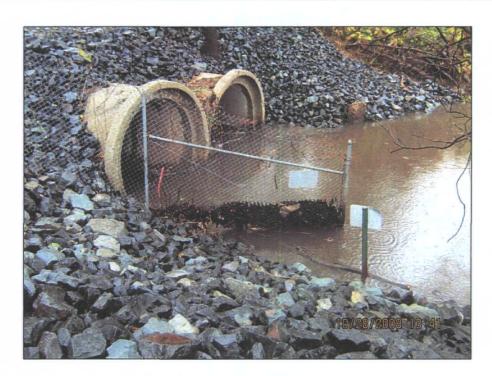
Picture 51: Increased stream height at the inlet to the twin culvert during rain (October 28, 2008).

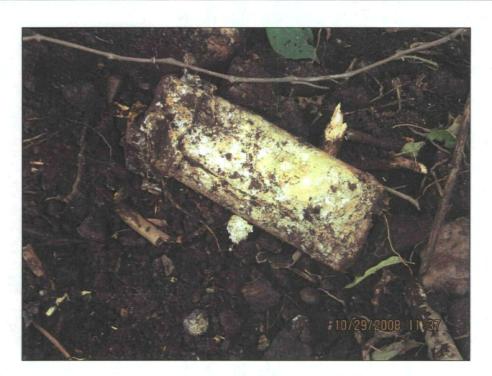
Picture 59: West bank downstream of the twin culvert. Example of capacitor discovered during clearing (October 29, 2008).

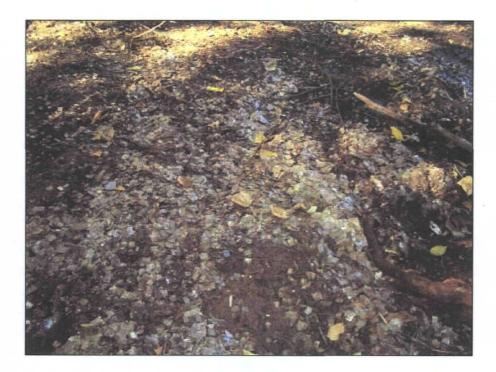
Picture 7: Capacitor film uncovered near Southwest corner of Site (October 15, 2008)
